# Stock Orchard Street

20+ and 60+ improvements  
explanatory narrative

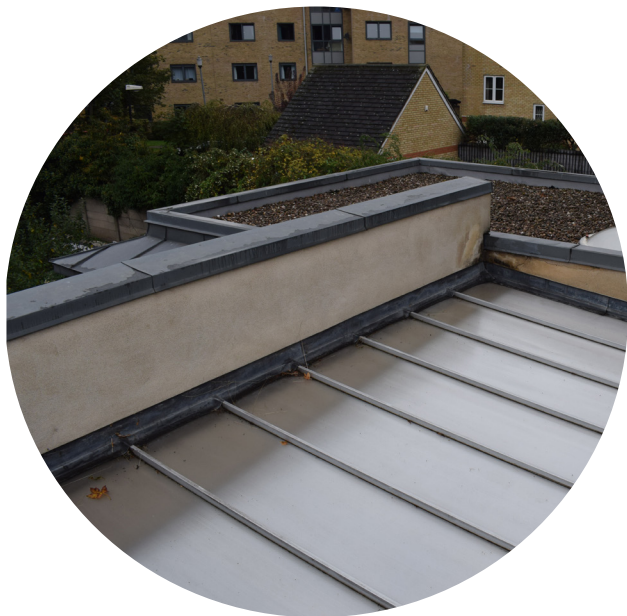
The polycarbonate rooflight did not perform very well. It has now been replaced with a solid, insulated roof with fixed rooflights and blinds. This will improve airtightness and reduce heat loss.

Details and guttering in this area have been improved in the process.

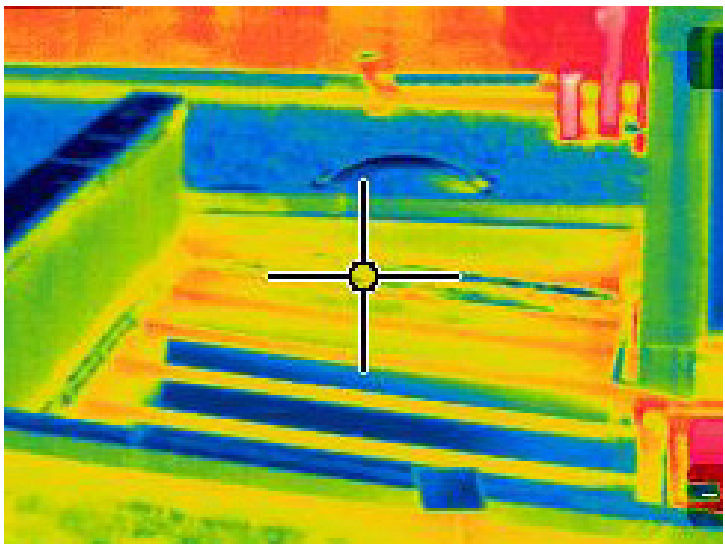
Thermal image showing air leakage and thermal bridging across the polycarbonate sheeting covering the link.

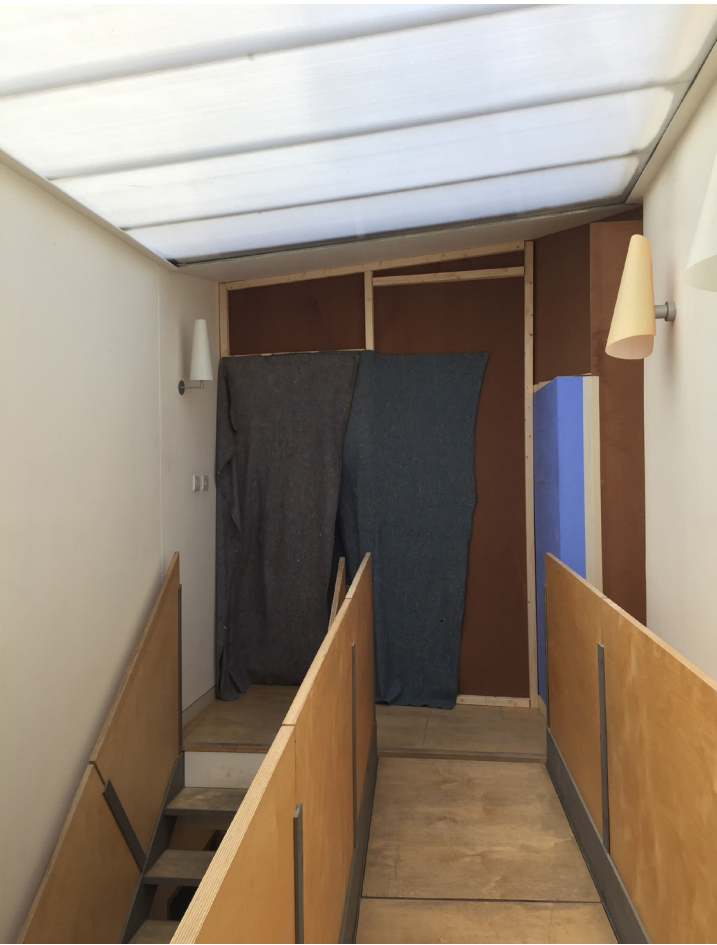
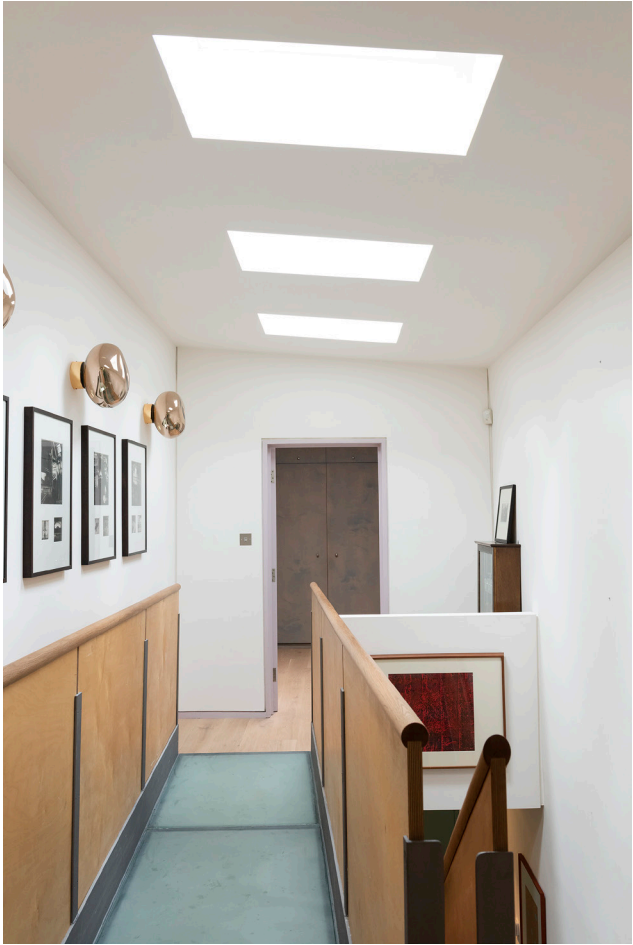
THE HALLWAY/LINK BLOCK

Images L to R: comparative images showing before (during construction) and after views of the link block. Note the absence of handrails to the bridge link and stair

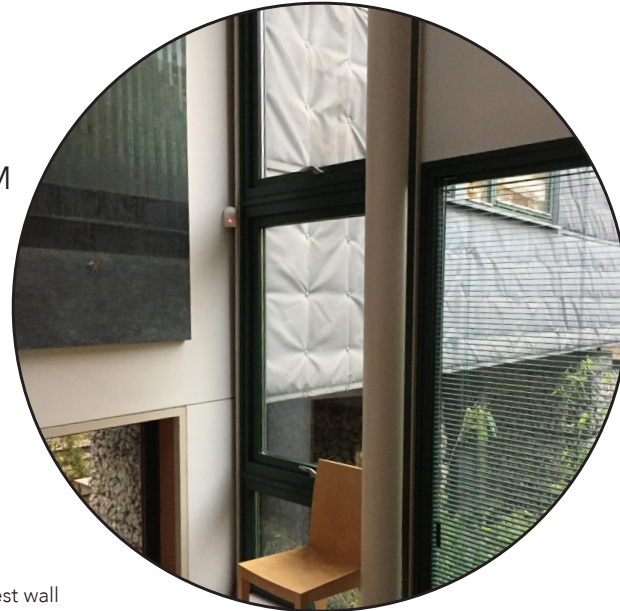
Existing south west wall

Thermal image showing air leakage and thermal bridging of steel at the top and in the ceiling.  
Image courtesy of Enhabit Ltd

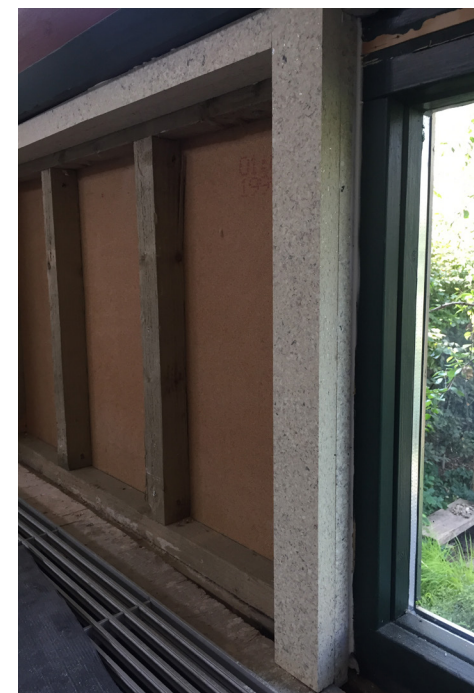
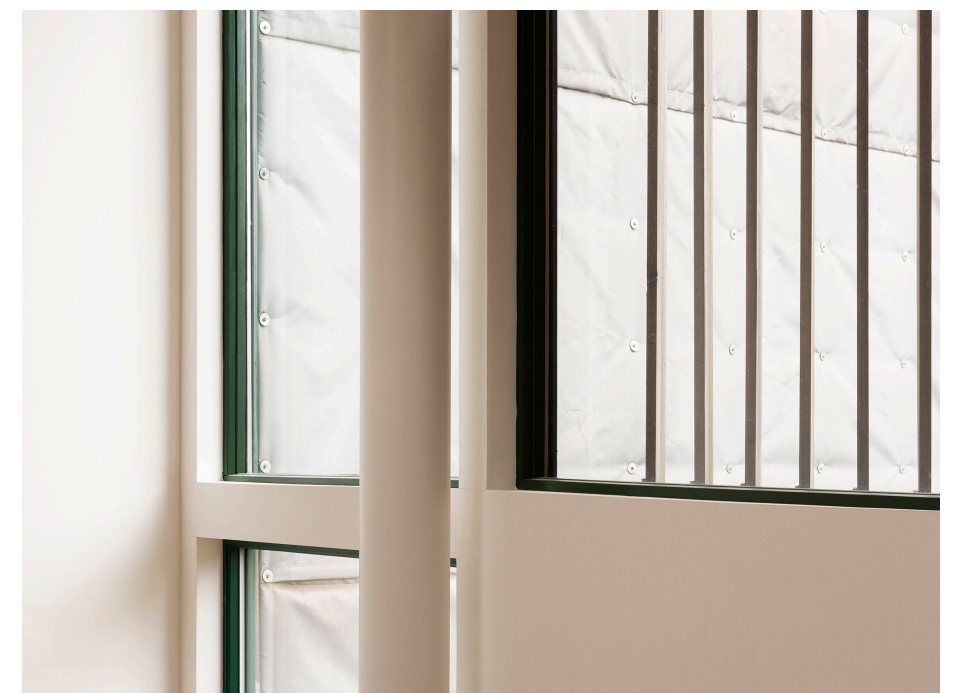
The southwest glazed wall comprised a framework of steel flats connected to the main columns that is located between the individual windows, forming a type of curtain wall. The steel frame penetrated the external envelope causing multiple thermal bridges and was not airtight. The proposal thickened out the wall with a solid insulated board, and airtightness tape was applied around all junctions. This thickened wall extended across all areas of the facade. The white areas of the image to the lower left shows the extent of these insulated areas.

Above, L to R: insulating the steels to the south-west wall.  
Wall with additional insulation.

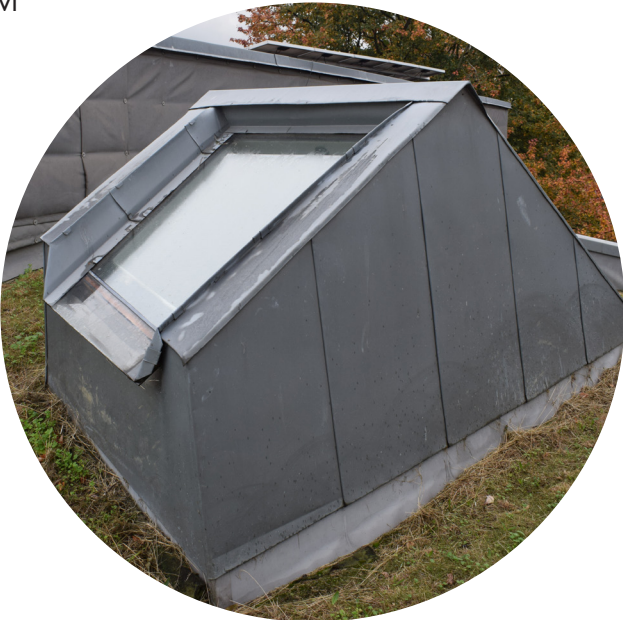
The existing rooflight was not airtight, and the glazing had a poor U-Value. To improve airtightness and provide summer ventilation this was replaced with an openable rooflight containing an integral solar control blind and blackout for when showing presentations in the conference room below.

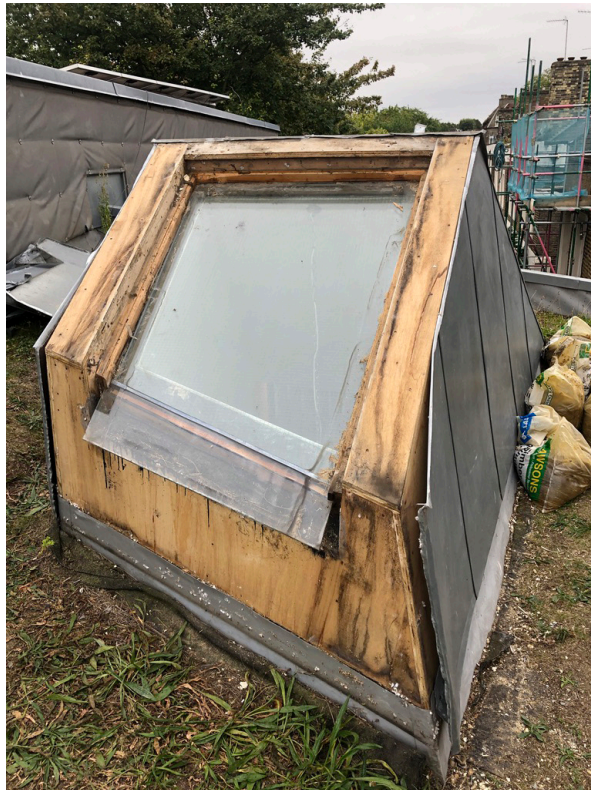
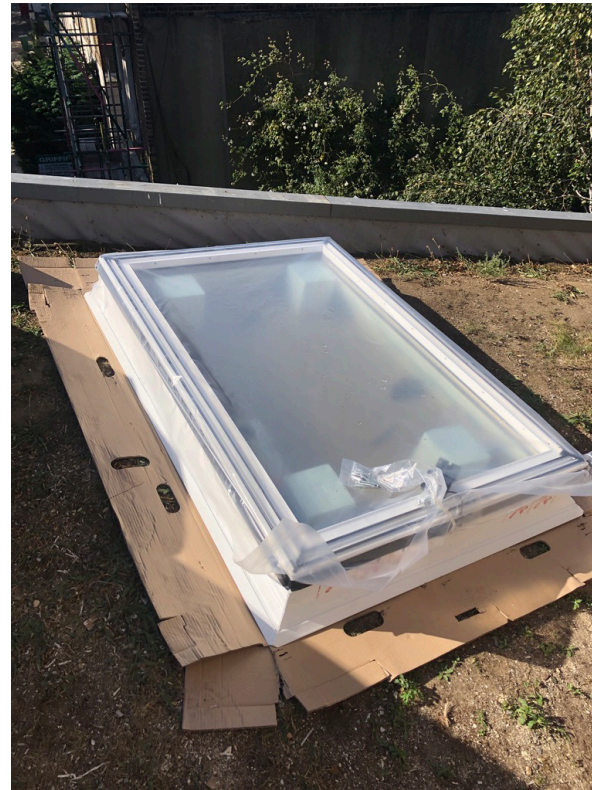
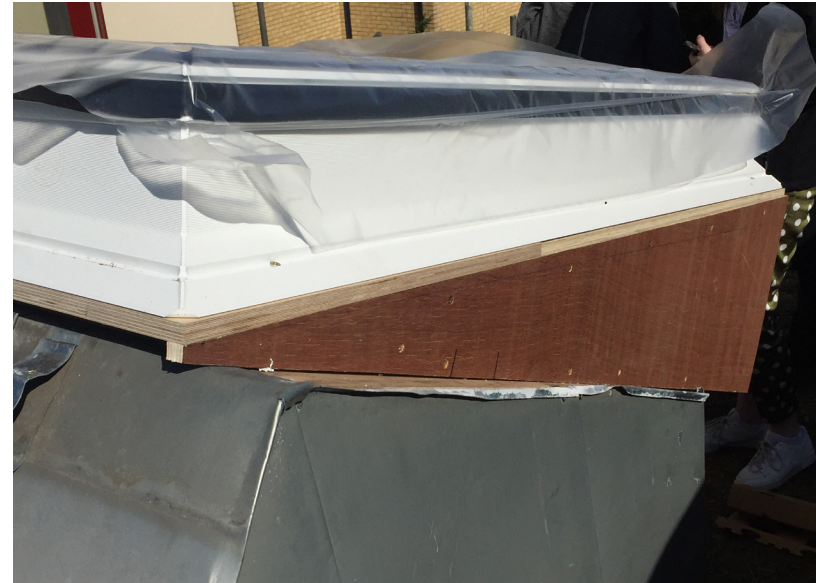
Top row, L to R: the conference room rooflight with zinc flashing removed.

The new rooflight on the grass roof has integral solar control blind and balcony. It is also openable using wifi controls from below.

The new rooflight could not be laid at a pitch greater than 15 degrees so the cheeks needed building up. Here the raising triangles set out the new location of the rooflight.

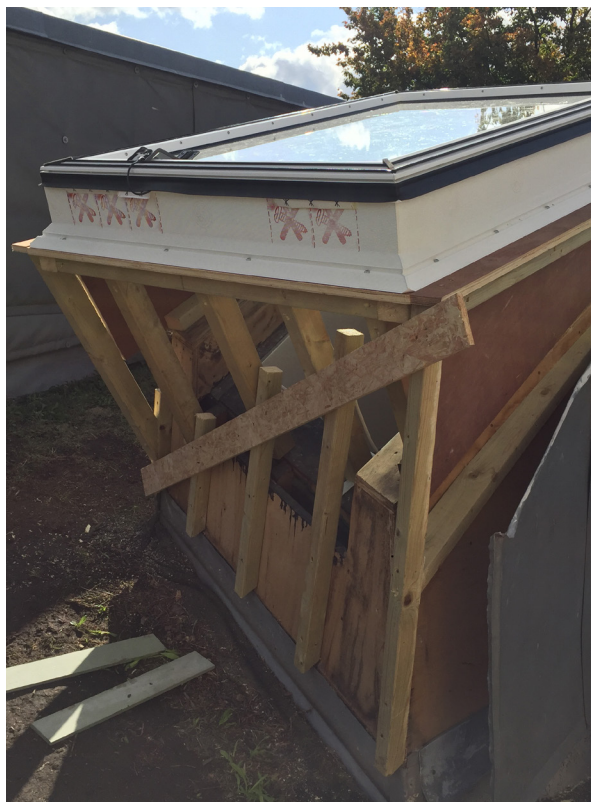
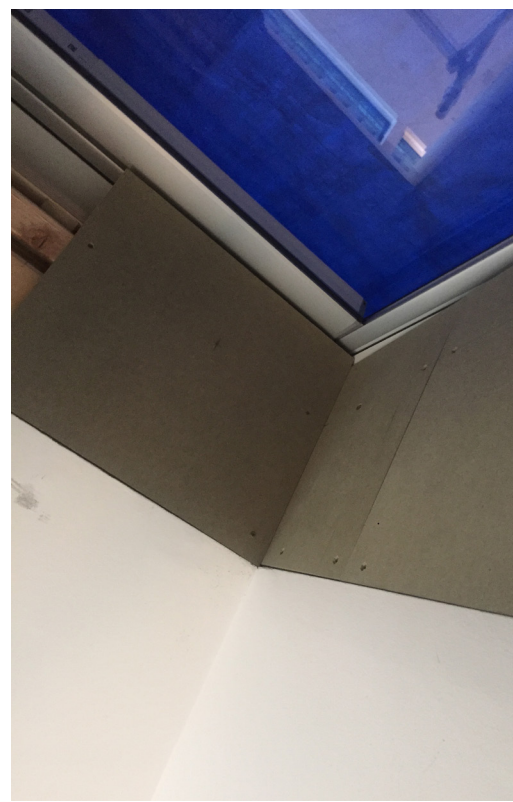
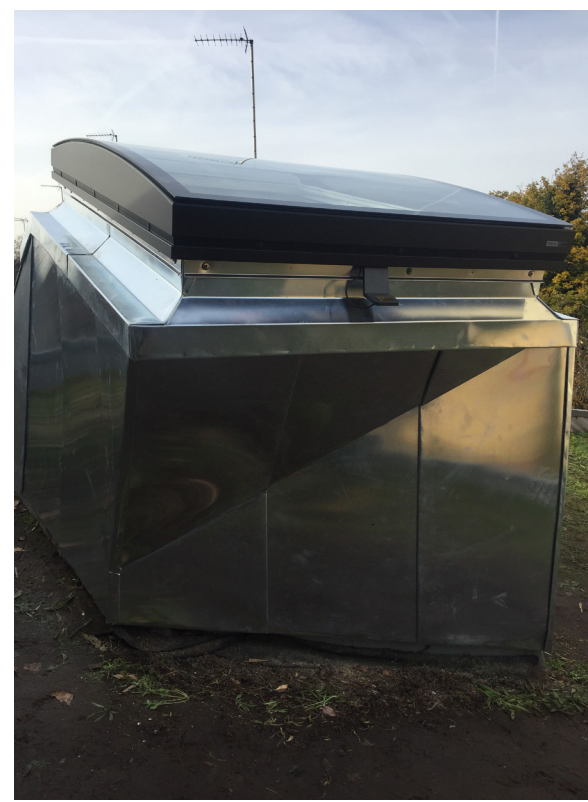
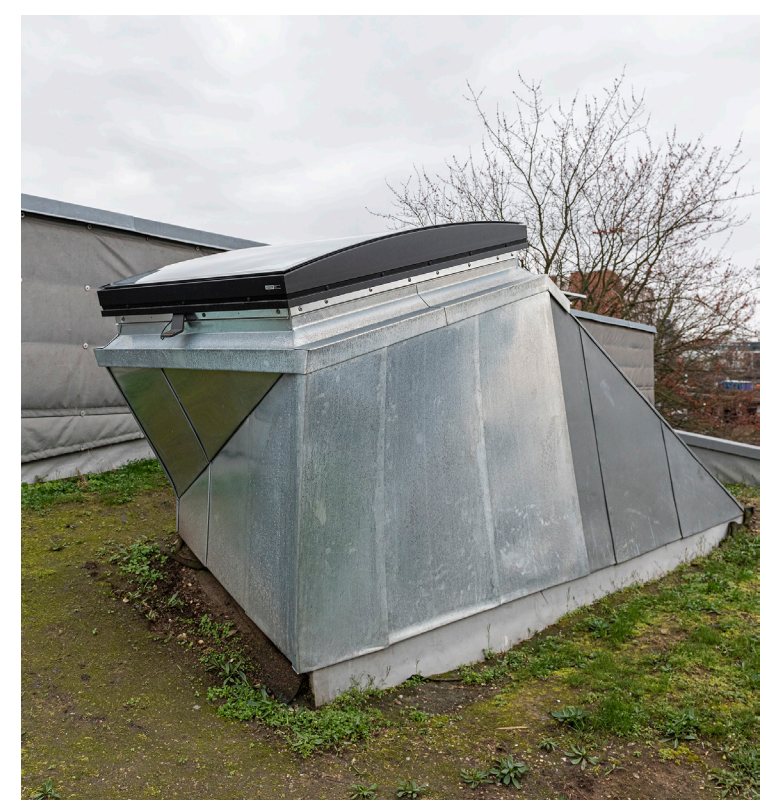
Bottom row, L to R: the new rooflight was not the same shape as the existing opening so the opening needed amendment. A 'fold' in the upstands was needed to accommodate it, shown here.

View of the rooflight from below. Internally the internal linings needed amending and raising to reach the new rooflight and air tightness membranes were installed to ensure no leakage in future.

Two views of the finished rooflight.

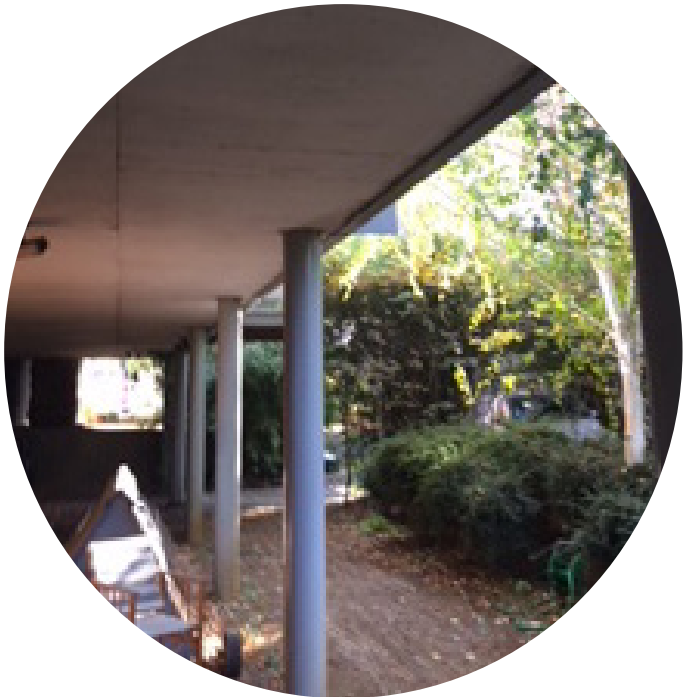
Reducing impact on the horizontal steel beams and improving the appearance of the house soffit. Airtightness taping around the steel columns helps to reduce risk of condensation

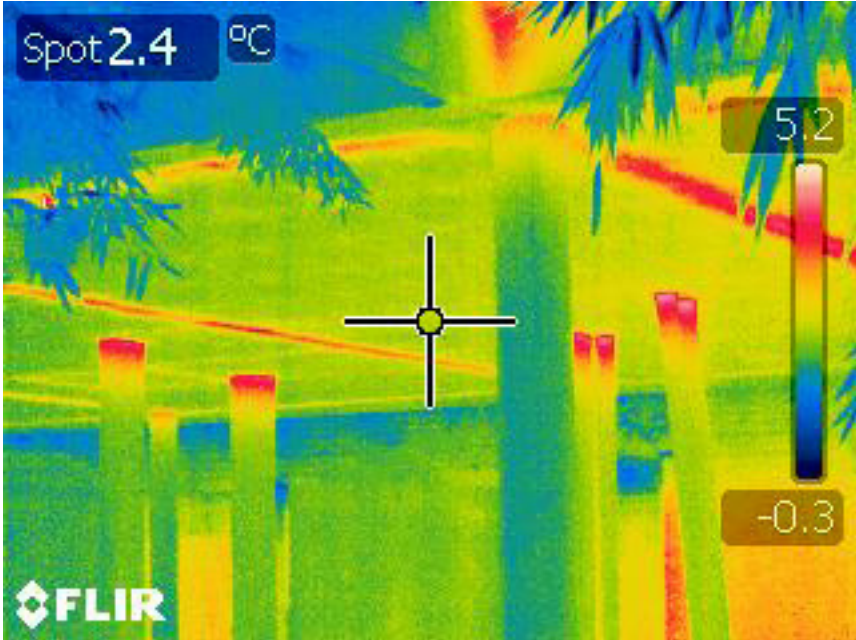
Thermal image of soffit showing thermal bridging image Courtesy of Enhabit Ltd

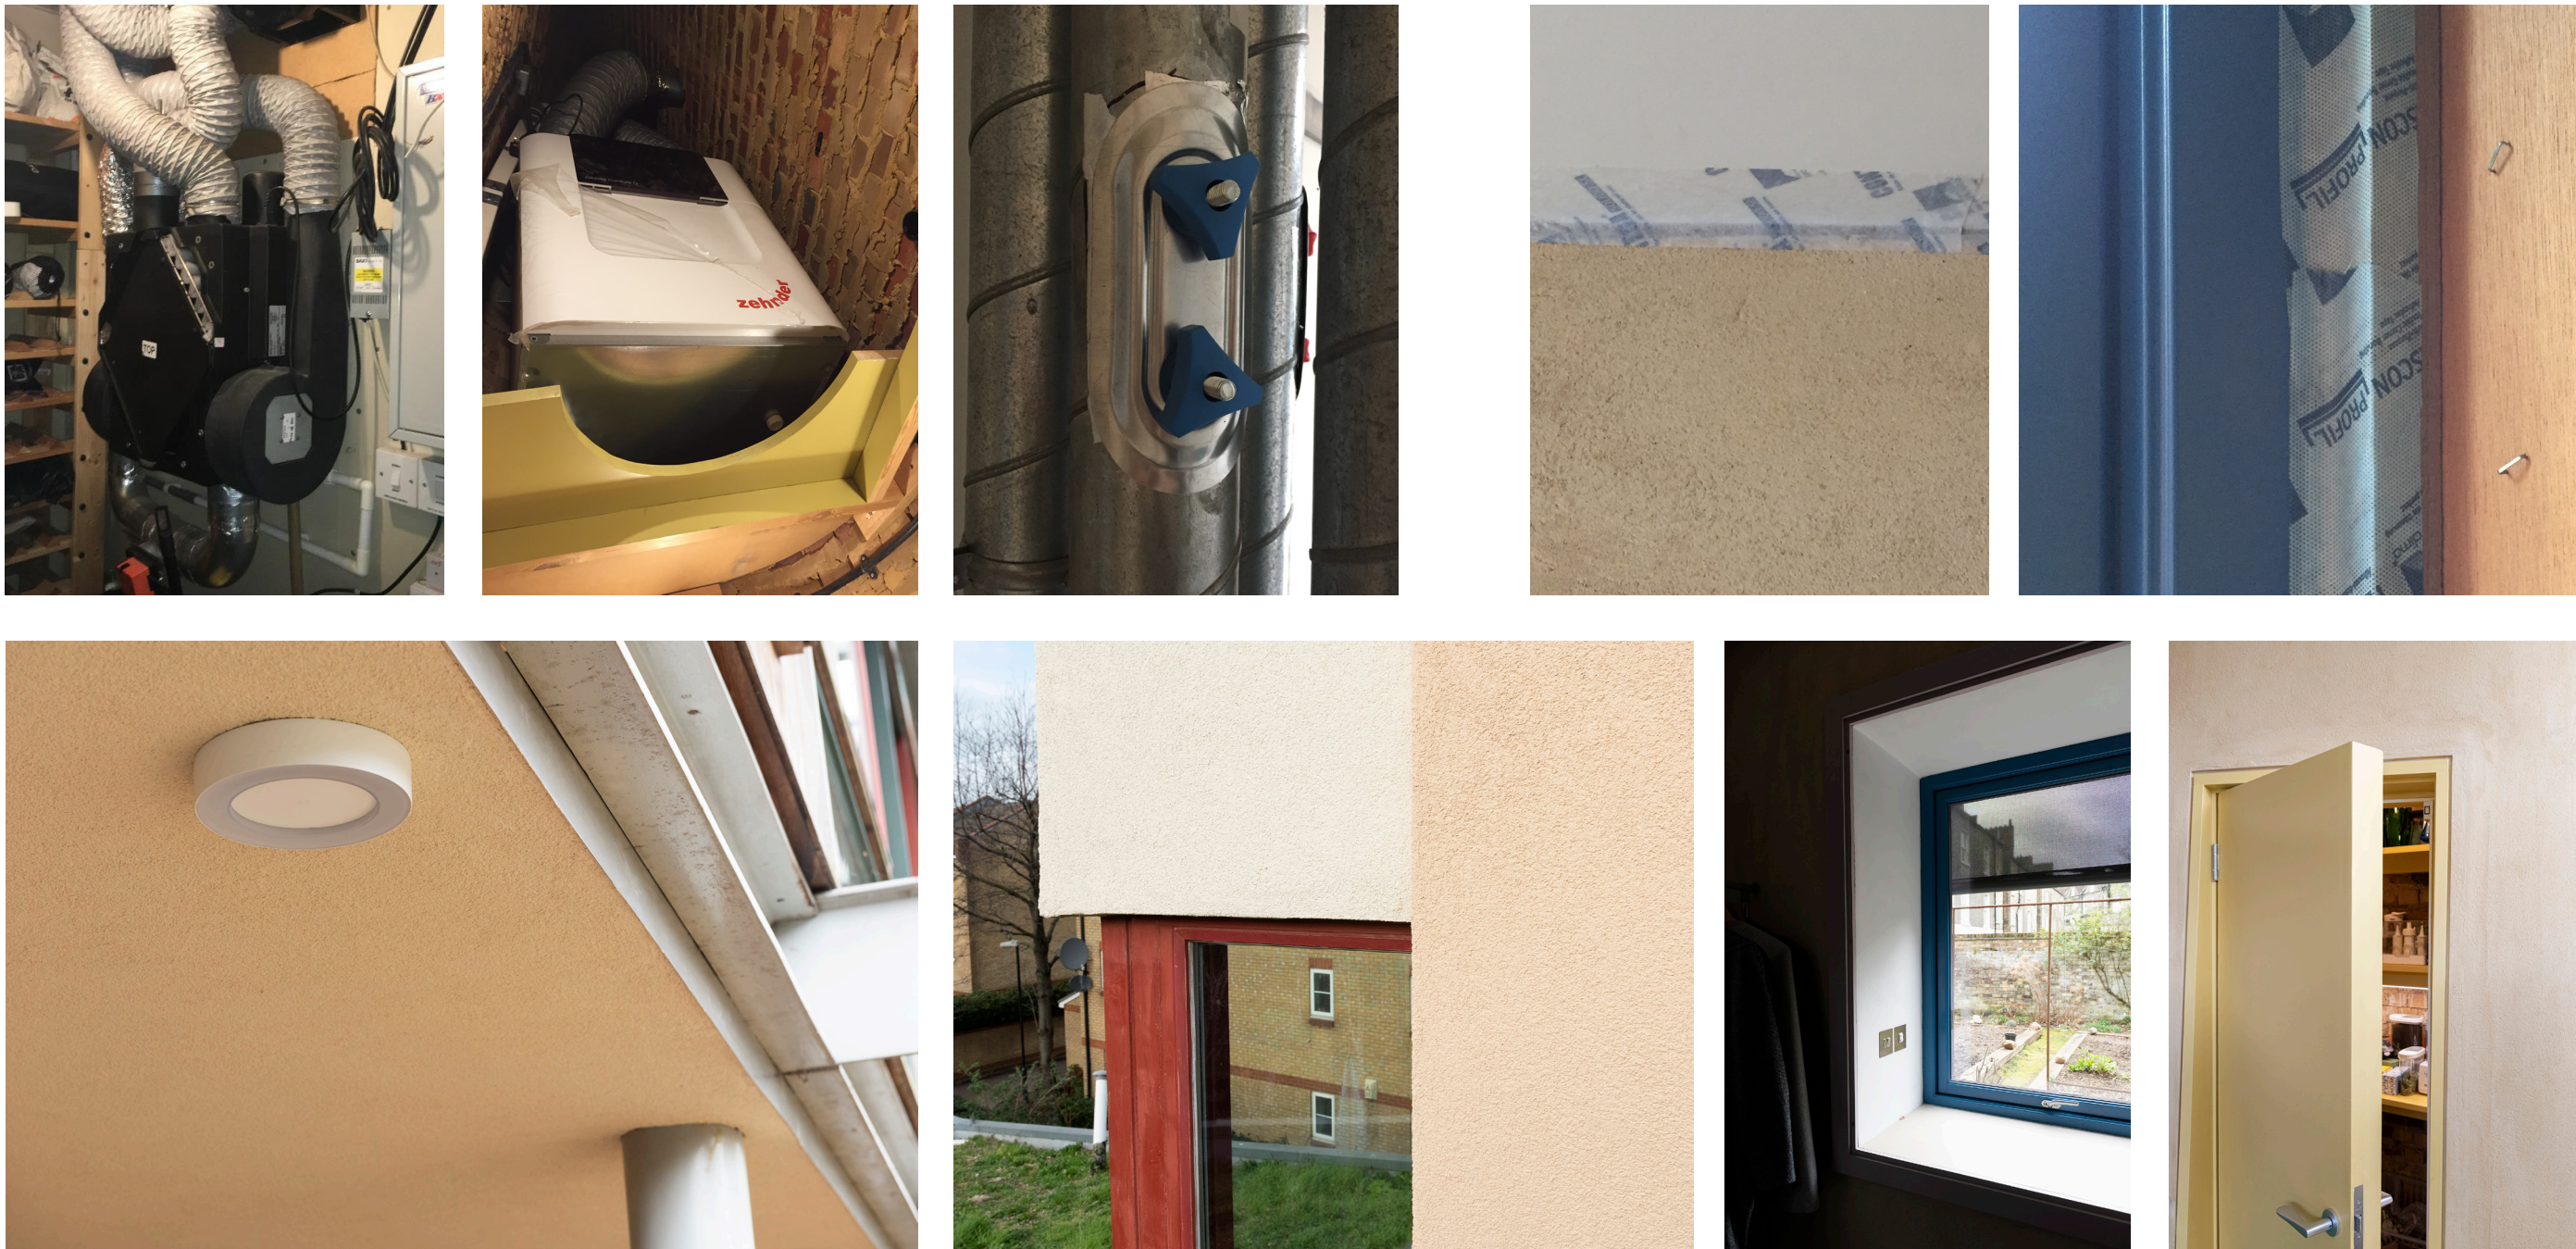
ECO (20+) IMPROVEMENTS

Top row: the original MVHR which was not commissioned properly; new MVHR in the larder; new access hatches to the cleaned MVHR ducts; air tightness tape being installed around window openings and at floor to ceiling junctions.  
Bottom row: newly insulated soffit to the house with LED lighting; new render to the walls of the tower; external solar control blinds over replaced windows to bedrooms reduce summer overheating; insulated and sealed larder door, keeping the coolth out of the heated spaces of the living
