# Stock Orchard Street

20+ and 60+ improvements  
explanatory narrative

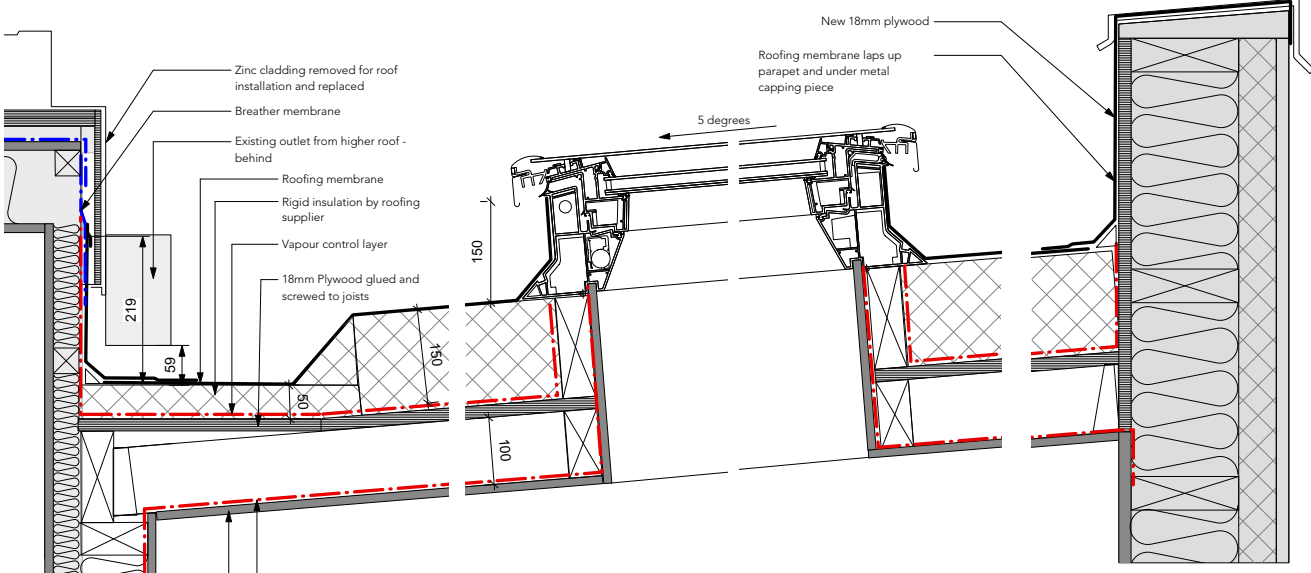
THE SOLUTION

The polycarbonate rooflight did not perform very well. It has now been replaced with a solid, insulated roof with fixed rooflights and blinds. This will improve airtightness and reduce heat loss.

Details and guttering in this area have been improved in the process.

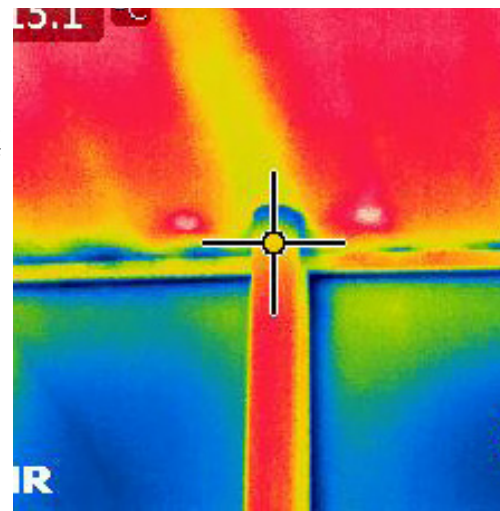
Thermal image showing air leakage and thermal bridging of steel at the top and in the ceiling.  
Image courtesy of Enhabit Ltd

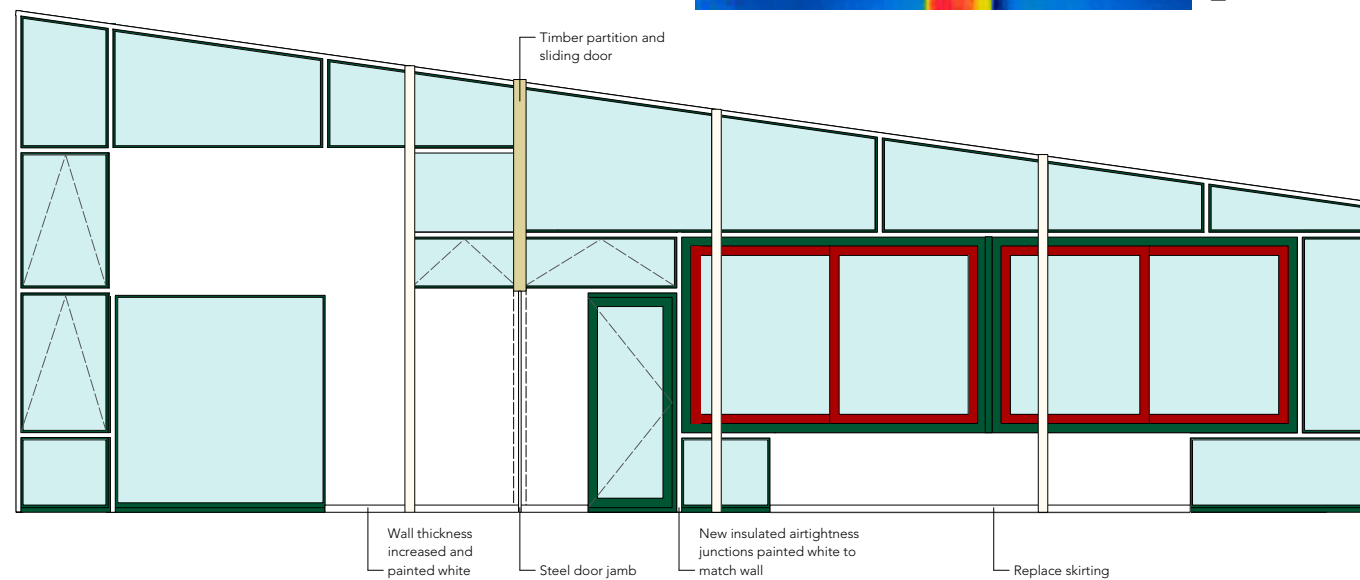
Internal elevation showing extent of insulated wall

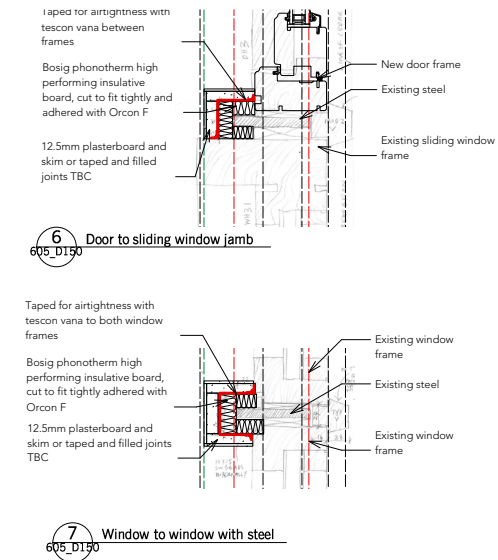
The southwest glazed wall comprised a framework of steel flats connected to the main columns that is located between the individual windows, forming a type of curtain wall. The steel frame penetrated the external envelope causing multiple thermal bridges and was not airtight. The proposal thickened out the wall with a solid insulated board, and airtightness tape was applied around all junctions. This thickened wall extended across all areas of the facade. The white areas of the image to the lower left shows the extent of these insulated areas.

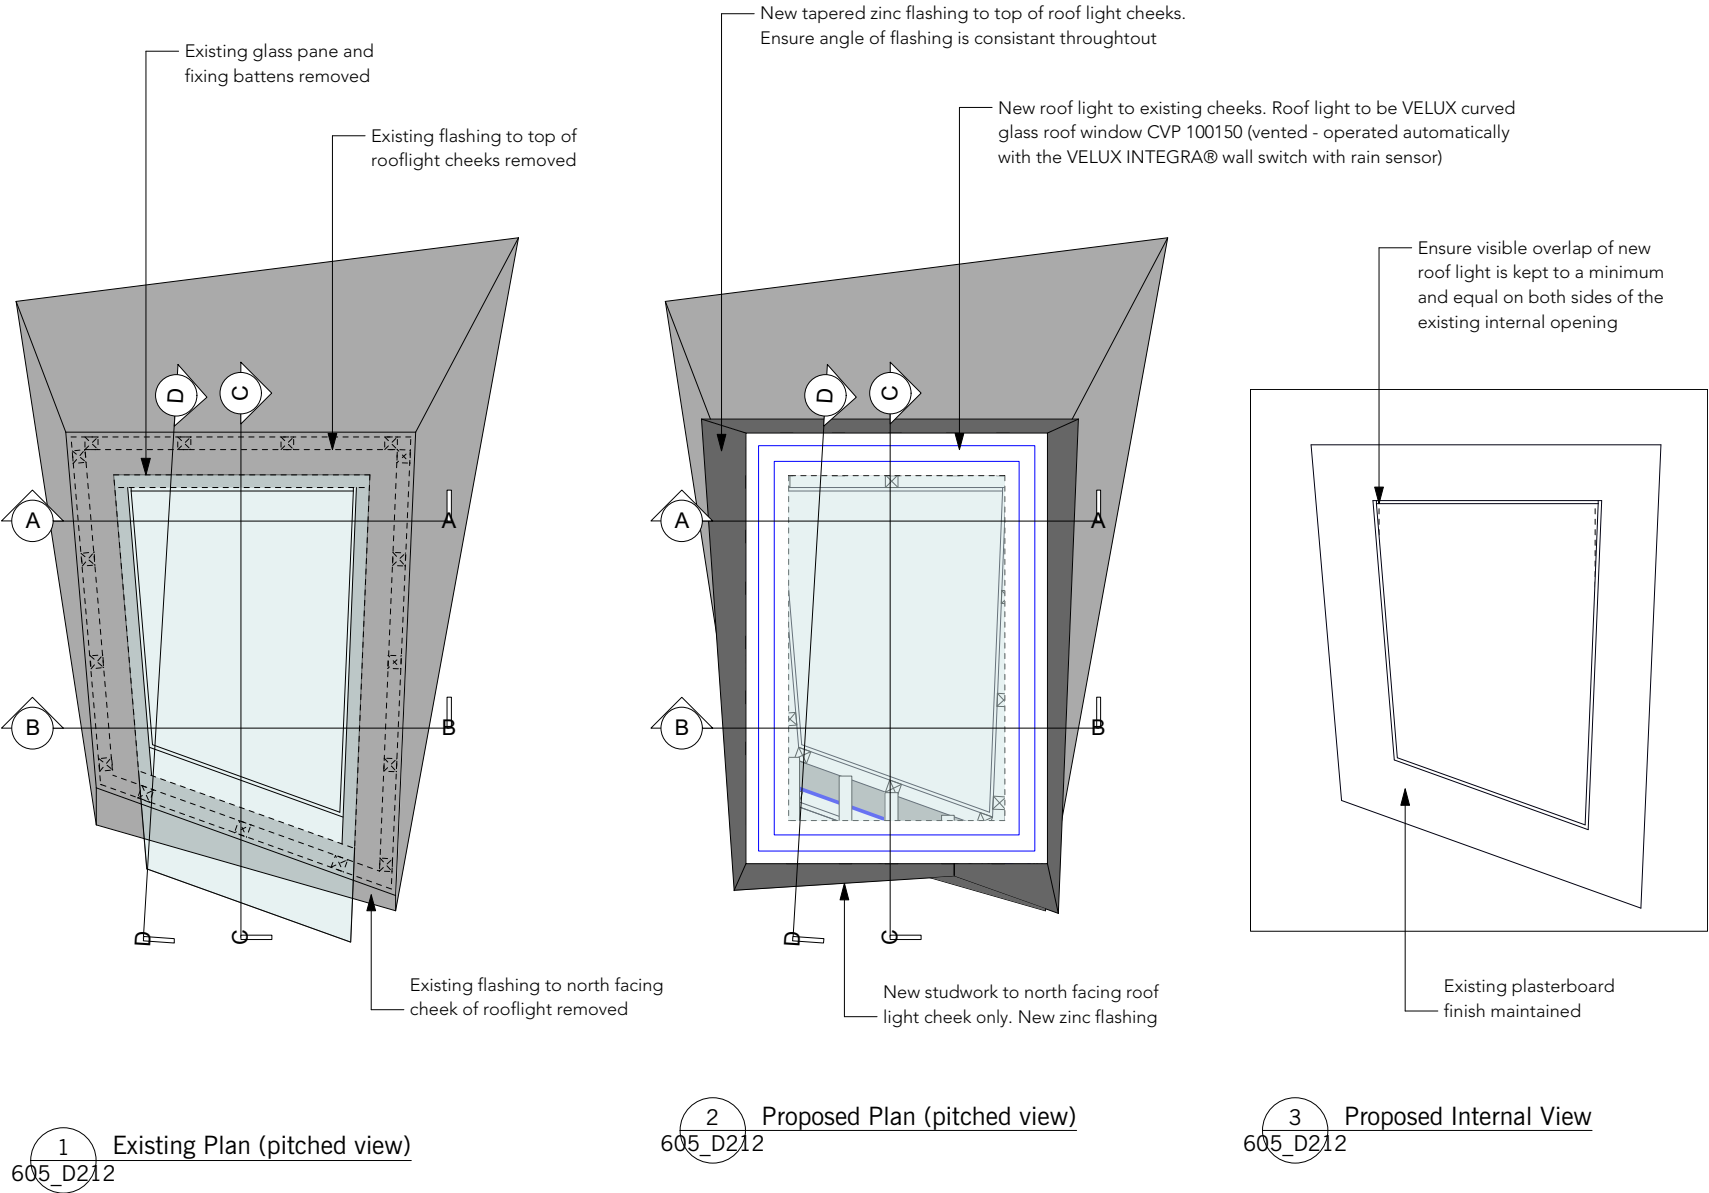
The existing rooflight was not airtight, and the glazing had a poor U-Value. To improve airtightness and provide summer ventilation this was replaced with an openable rooflight containing an integral solar control blind and blackout for when showing presentations in the conference room below.

Drawing showing the proposed replaced rooflight on the existing base

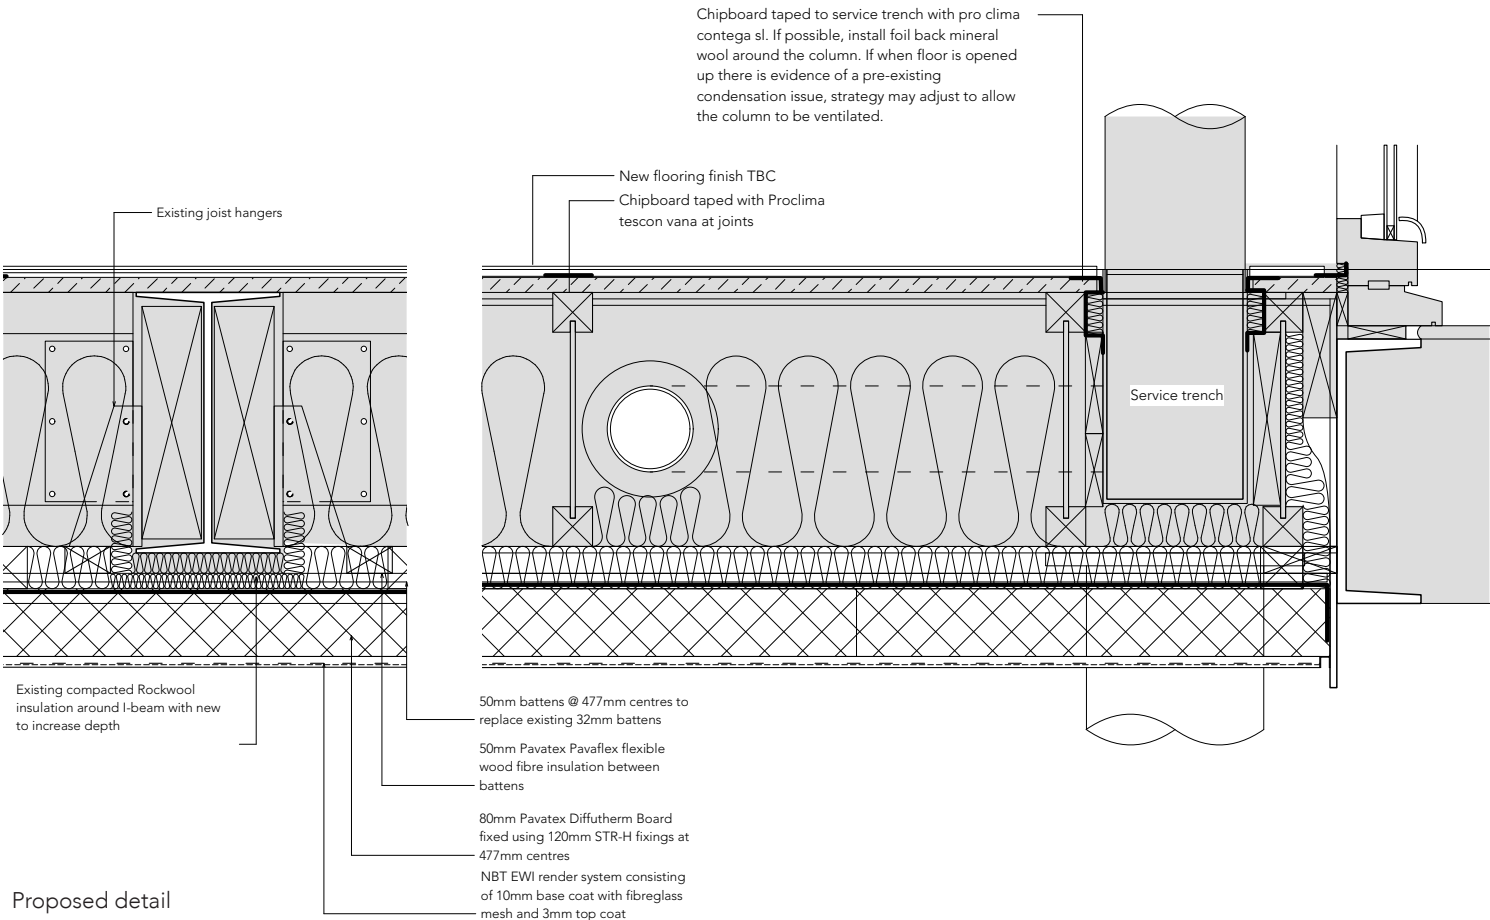
Reducing impact on the horizontal steel beams and improving the appearance of the house soffit. Airtightness taping around the steel columns helps to reduce risk of condensation

Thermal image of soffit showing thermal bridging image Courtesy of Enhabit Ltd

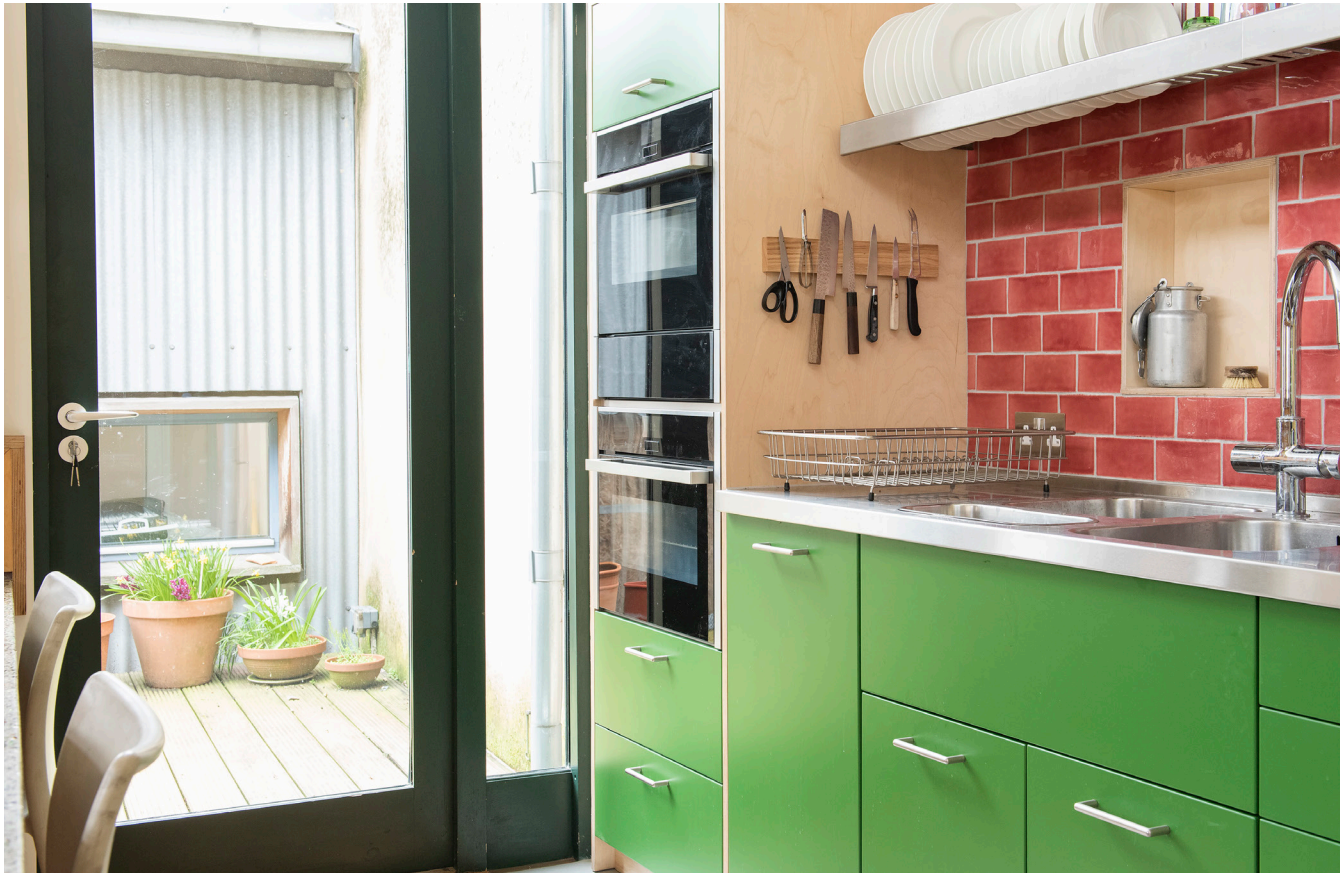
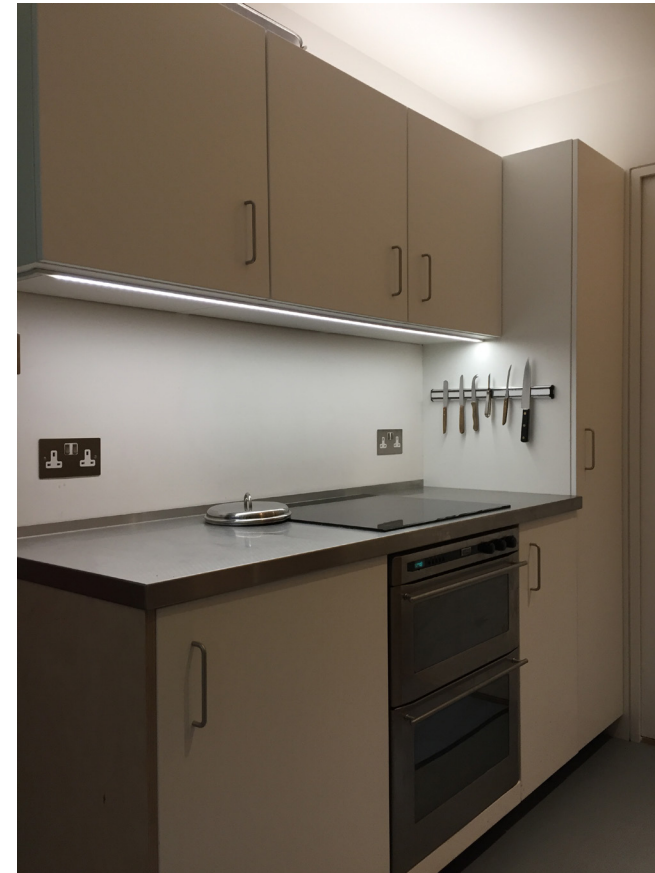
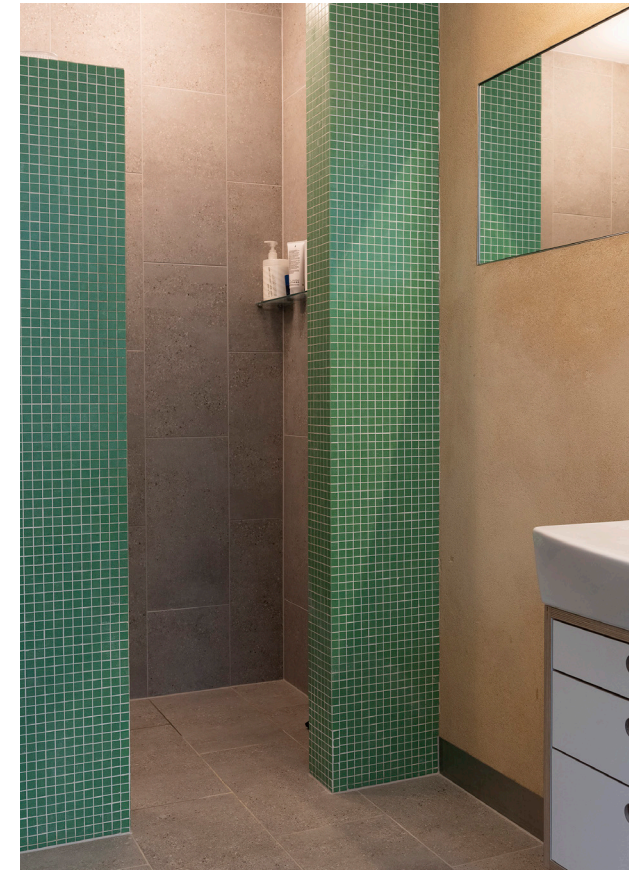
Clockwise from above:  
Eye-level ovens remove the need to bend down; a new kitchen for a future carer was installed on the ground floor - together with the bedroom and separate bathroom this forms a suite of rooms for independent living, a carer or a relative; new level access shower; handrails in the bathroom; new handrails to staircase and bridge.
